PERATION

GREENHOUSE

SCIENTIFIC DIRECTOR'S REPORT

ANNEX 3.2 U. S. NAVY STRUCTURES

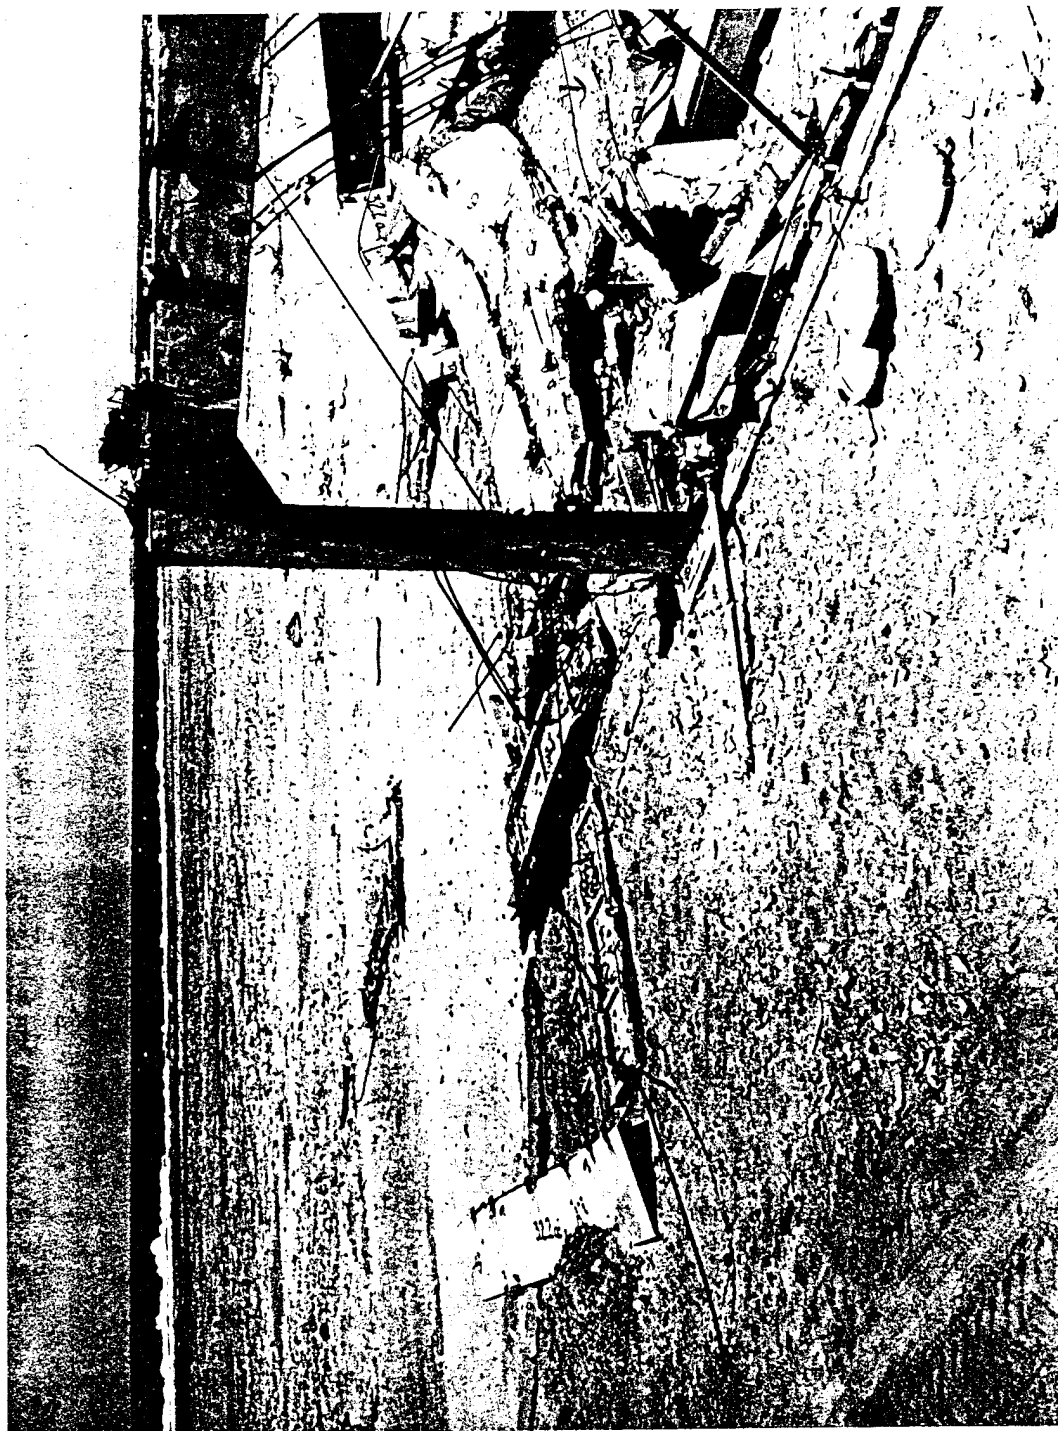
Fig. L.67 View toward Rear from Left Side, Structure 3.2.2a

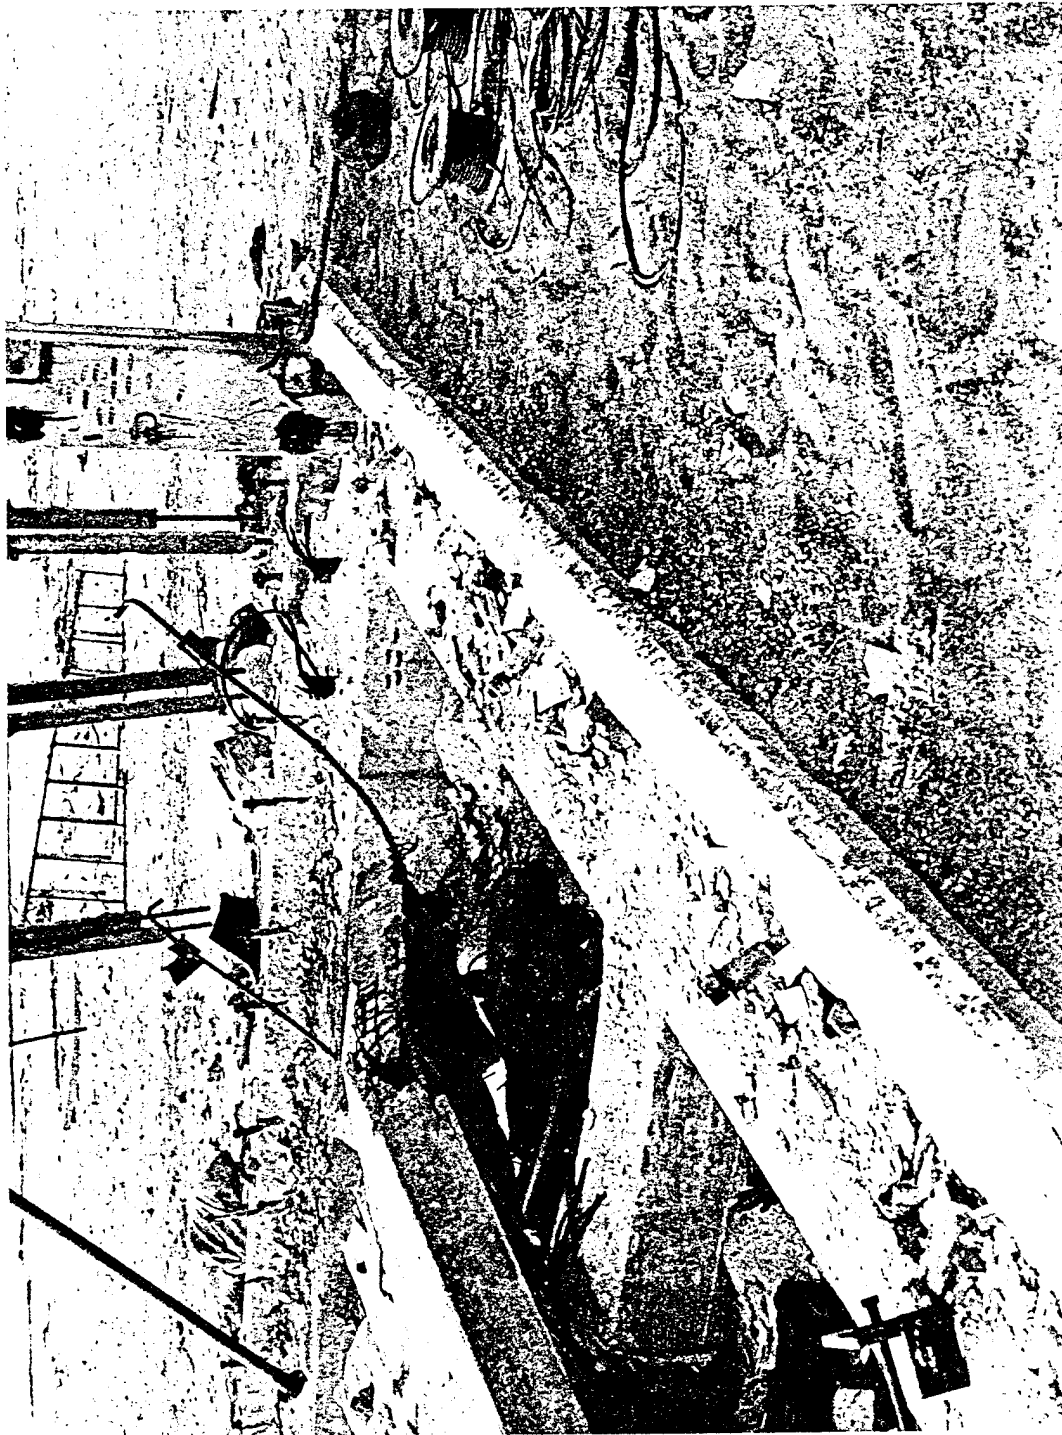
Fig. L.68 Anchor Bolts Bent In by Lower Panel on Right Front Side, Structure 3.2.2a. Concrete failed around pipe sleeves.

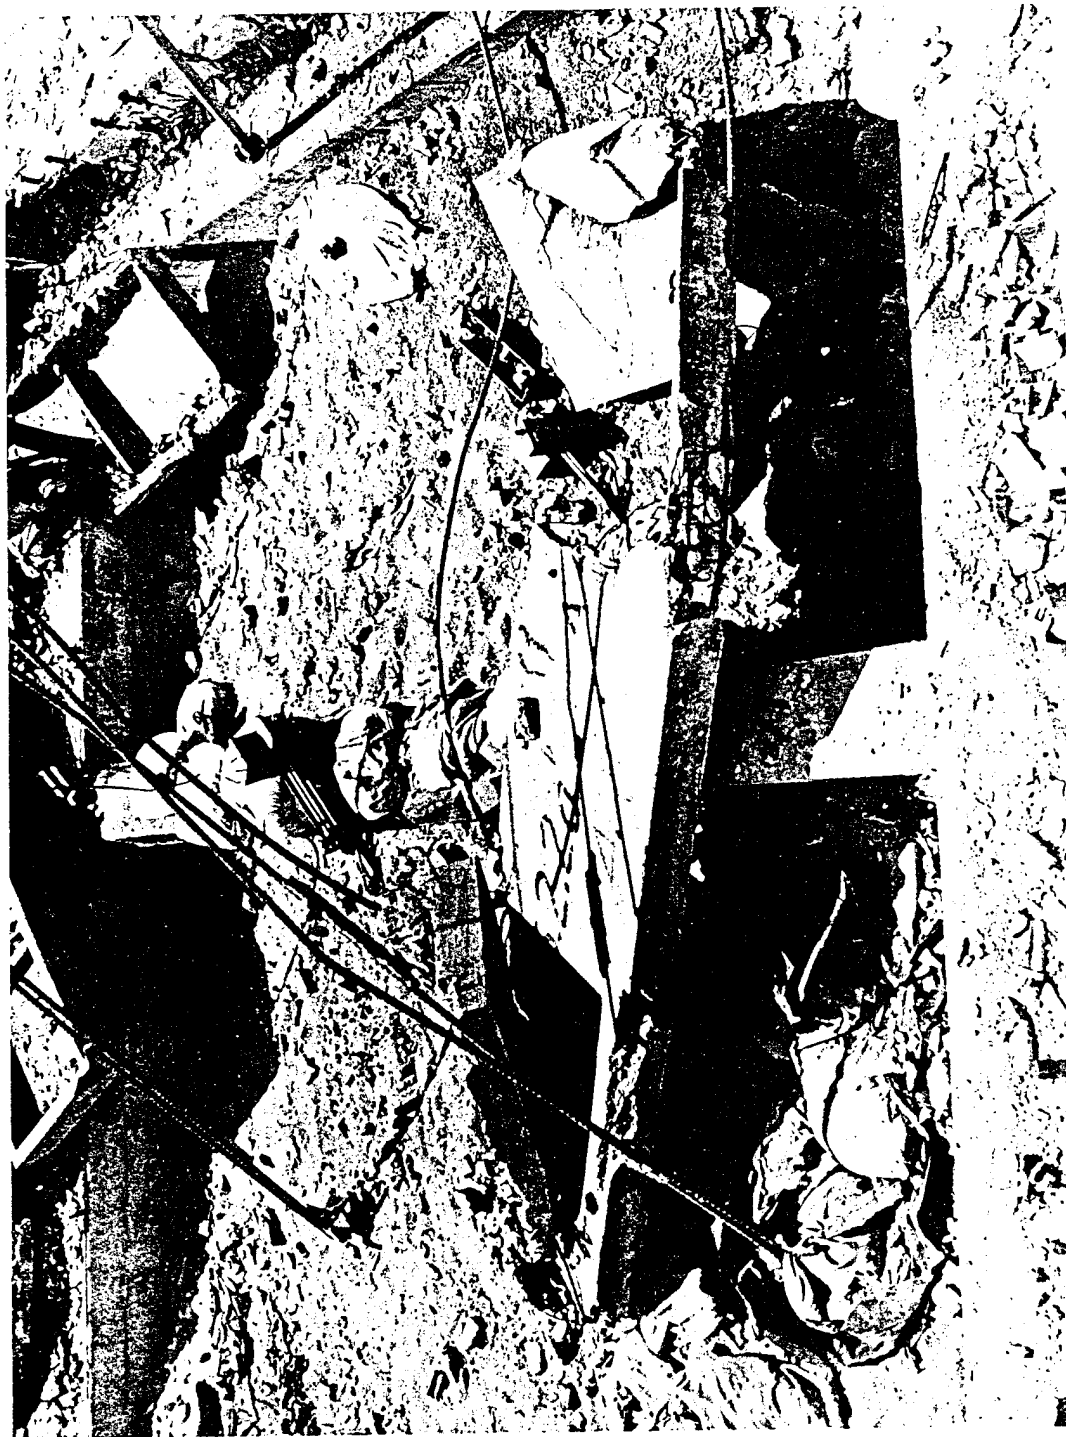
Fig. L.69 Lower Right Front Panel Inside Structure, 3.2.2a

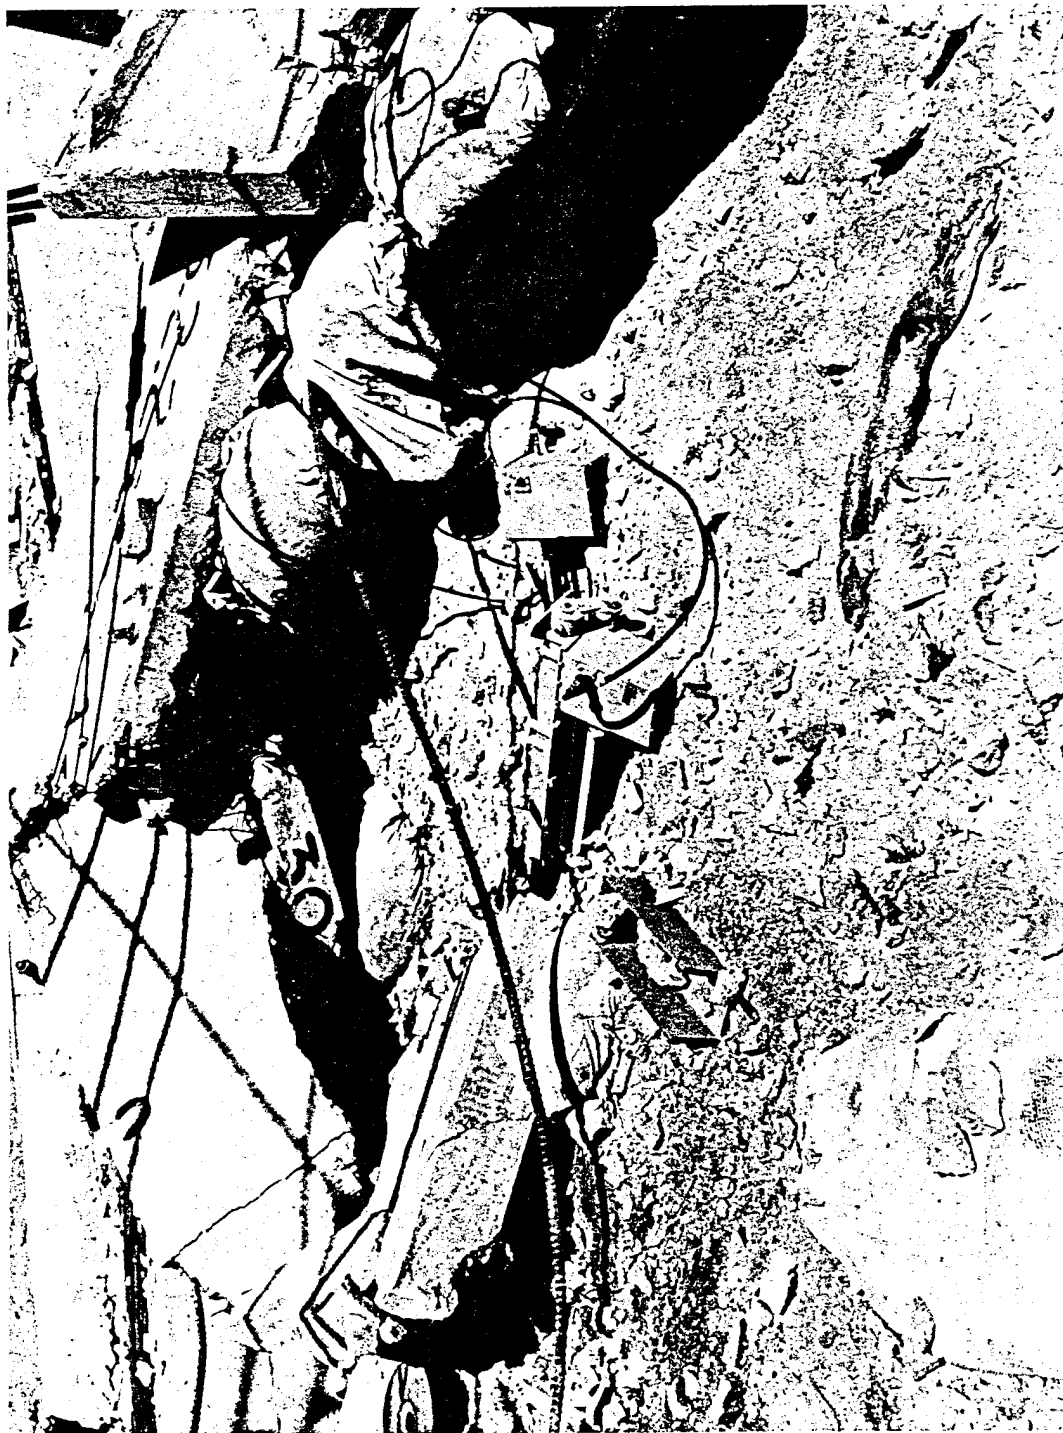
Fig. L.70 Center Right Front Panel at Rear Interior, Structure 3.2.2a

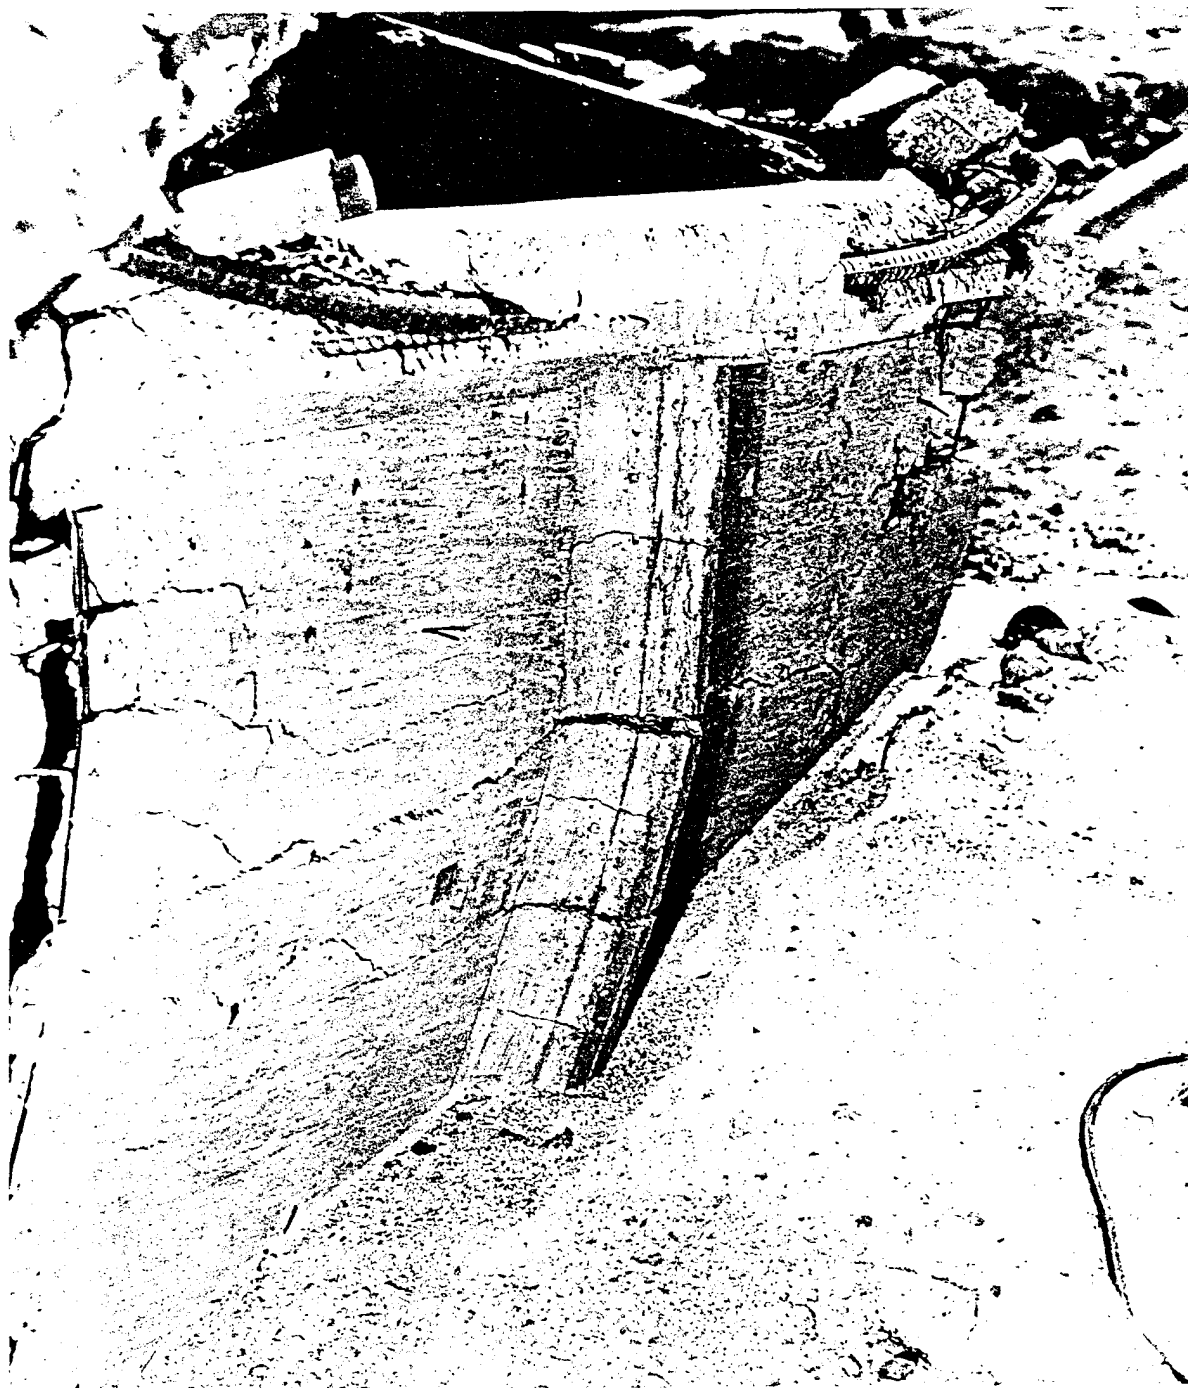
Fig. L.71 Upper Right Front Panel Deformed 2 in. across 30-in. Width before Panel Gave Way at Ends,
Structure 3.2.2a

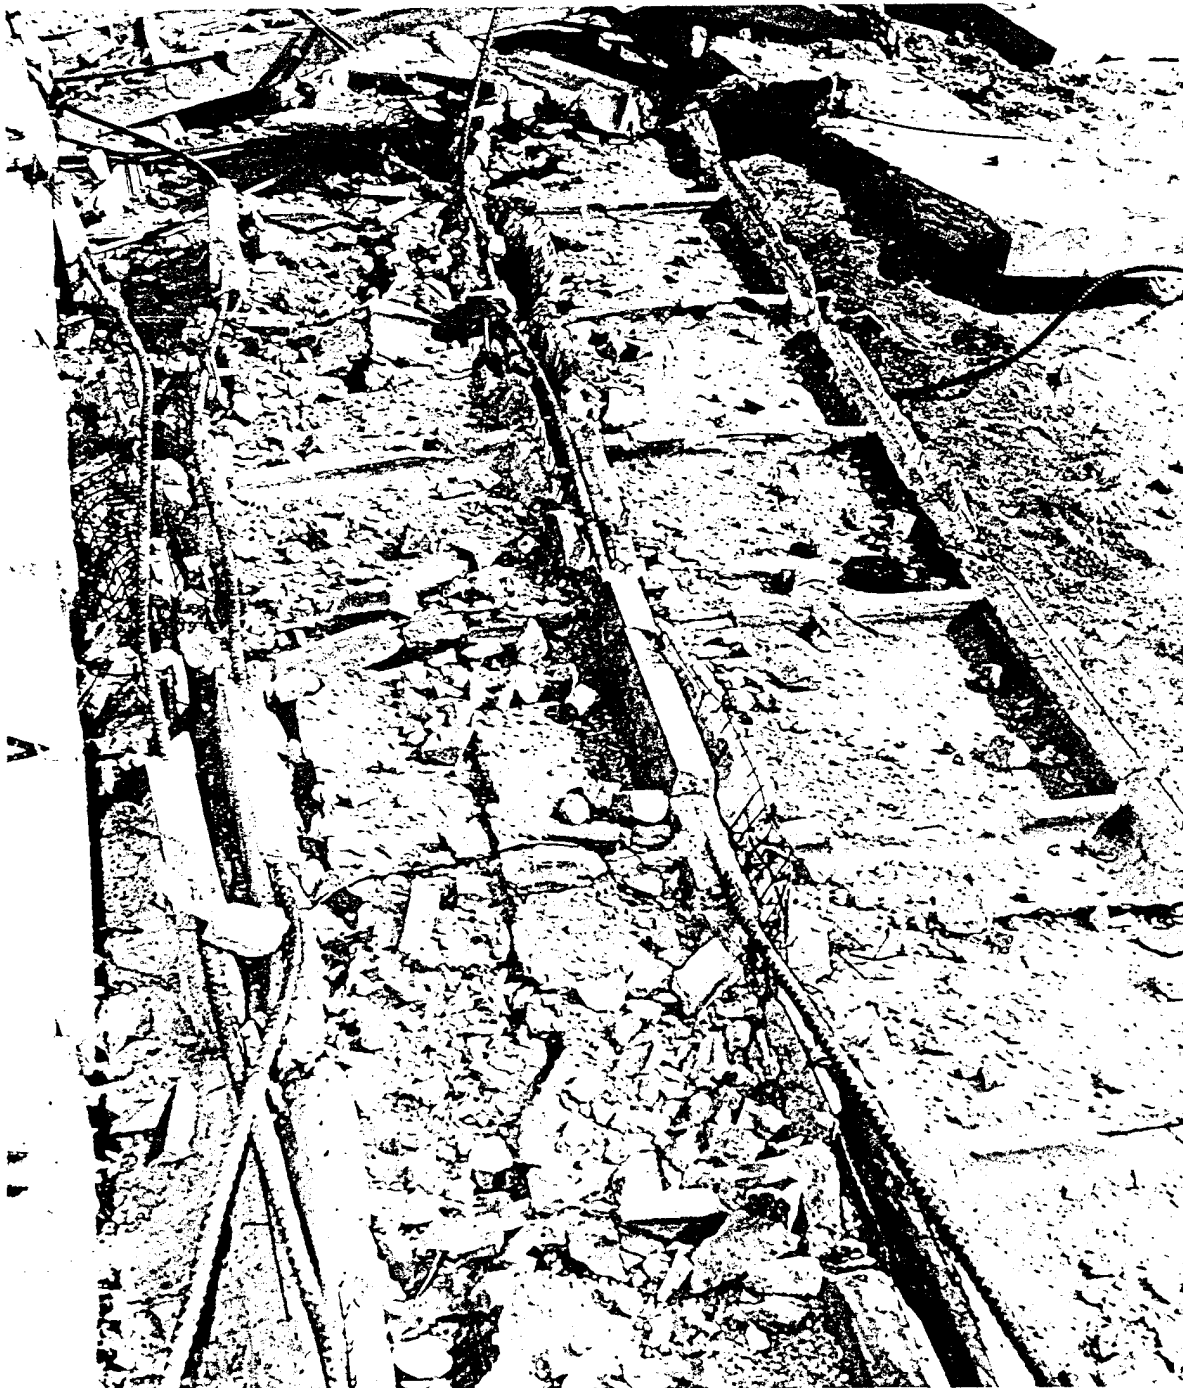
Fig. L.72 Downward Deformations in Roof Panels Which Occurred before Blast Wave Entered Structure, 3.2.2a

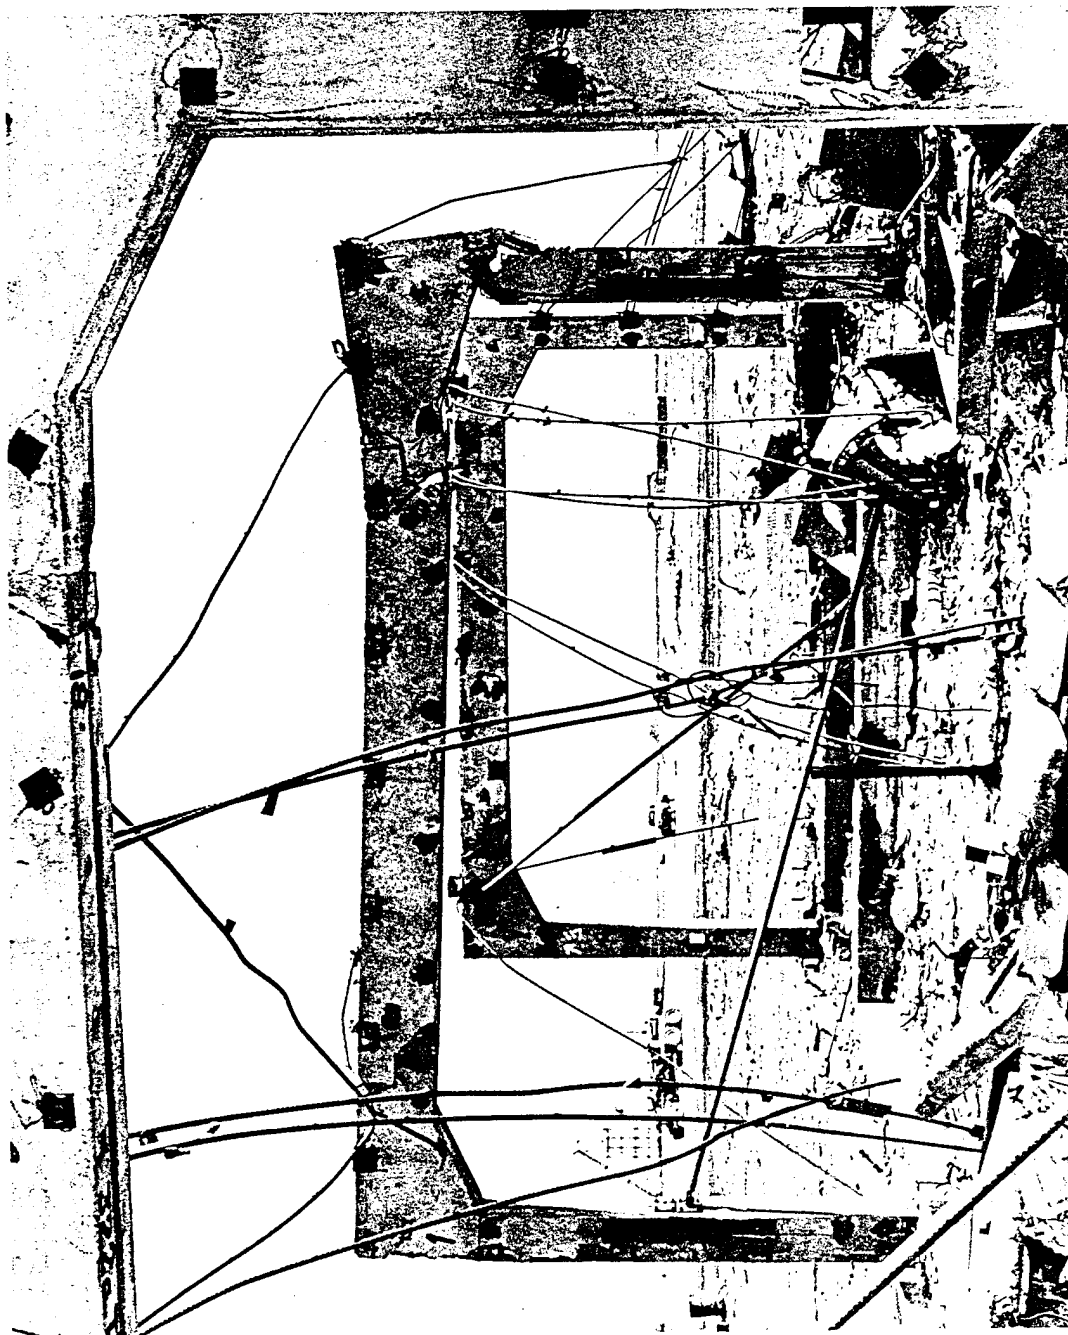
Fig. L.73 View from Right Side Showing How Tension Steel in Roof Panels Held at Ends of Building and Panels Pushed Up, the Concrete Around Steel Falling in Tension, Structure 3.2.2a. On center bent load was greater and bolts anchoring panels to bents failed.

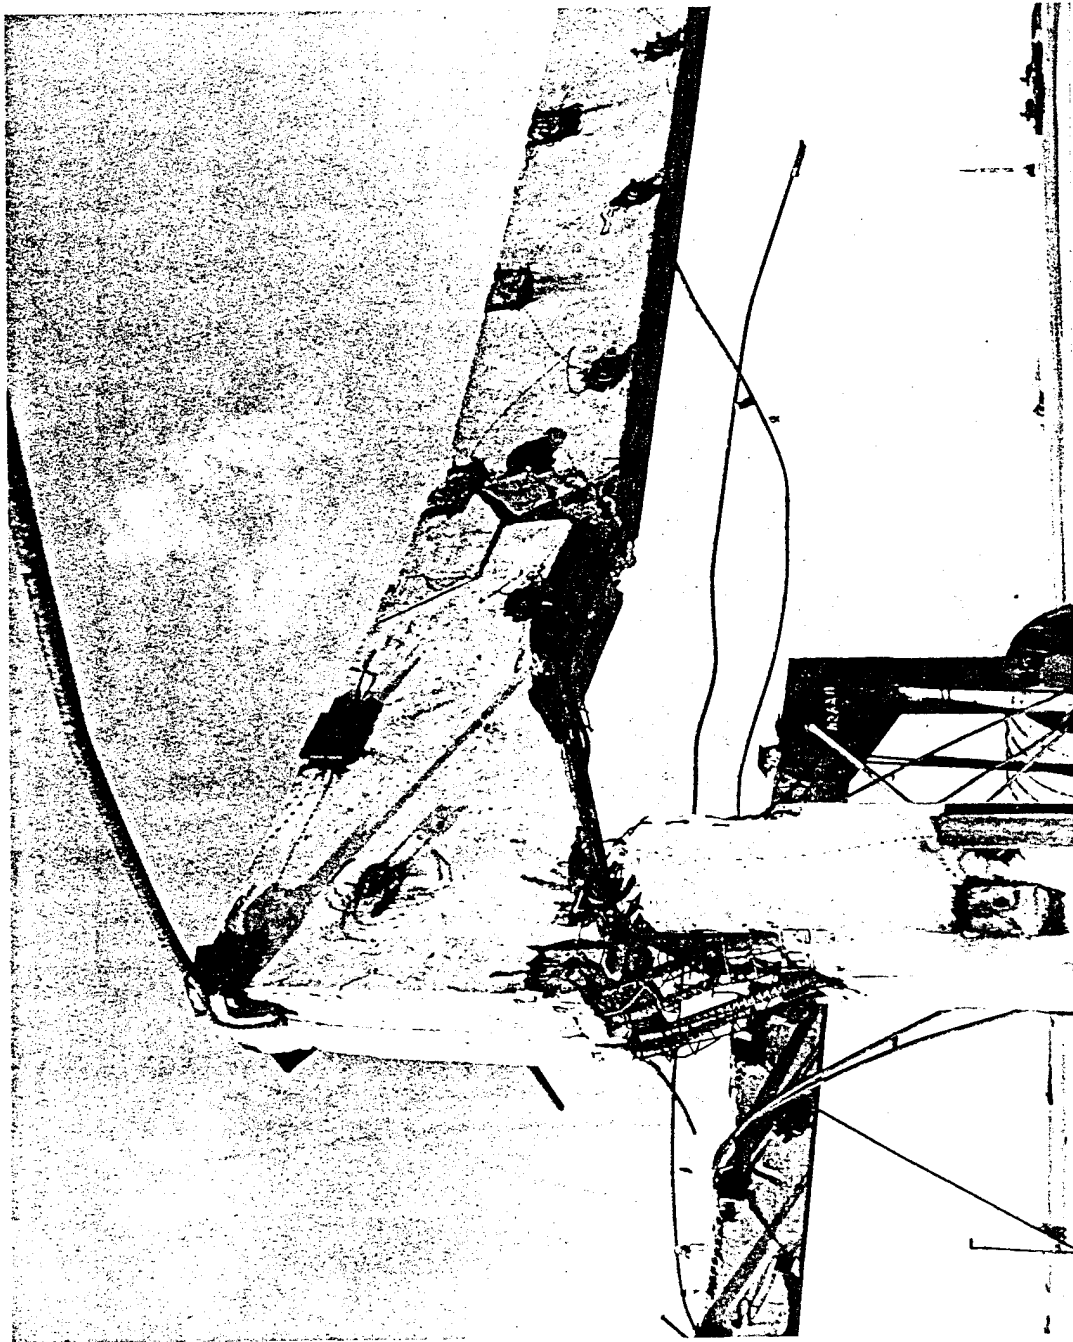
Fig. L.74 Moment Failure at Rear Haunch of Center Bent, Structure 3.2.2a

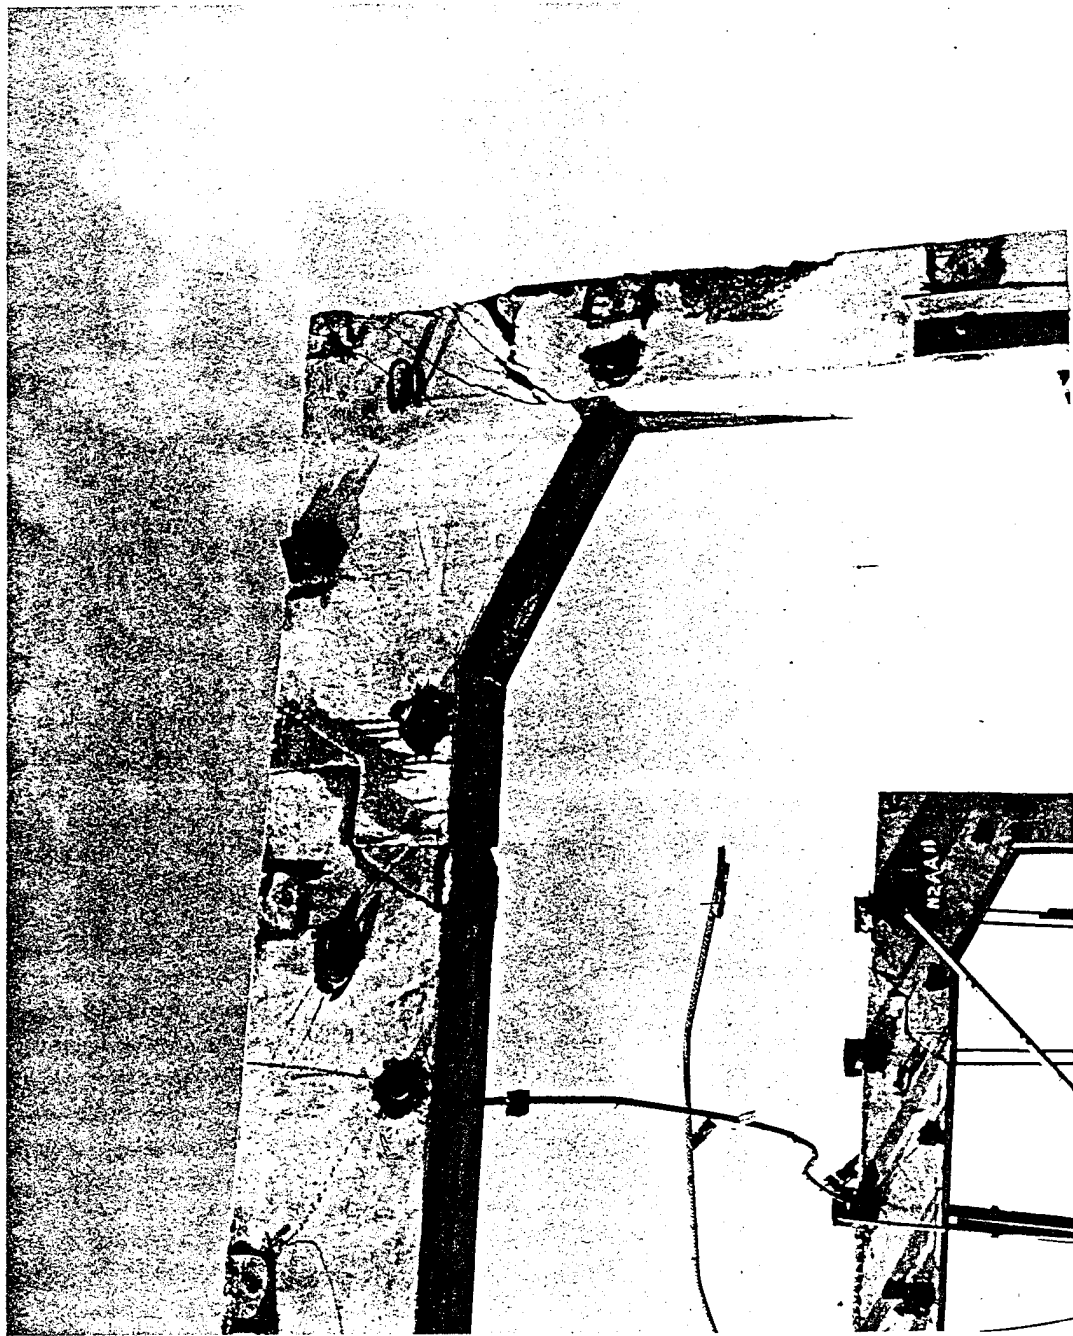
Fig. L.75 Front Haunch of Center Bent, Structure 3.2.2a

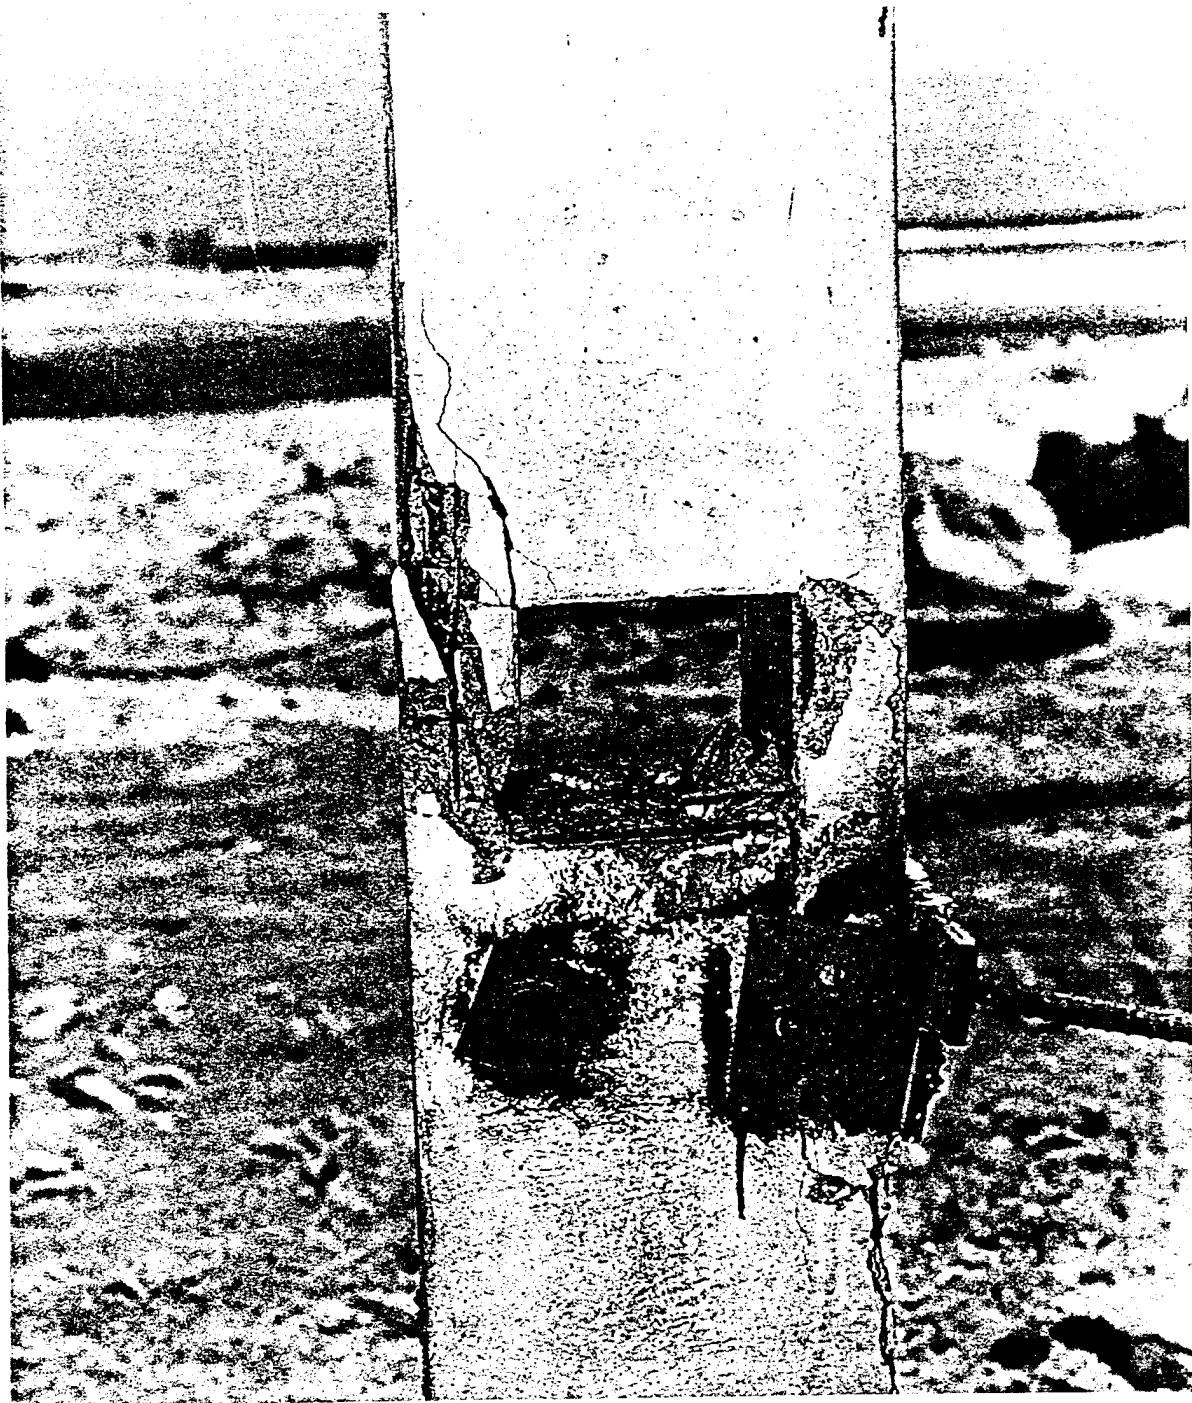
Fig. L.76 Moment at Grout Hole of Rear Column of Left Bent, Structure 3.2.2a

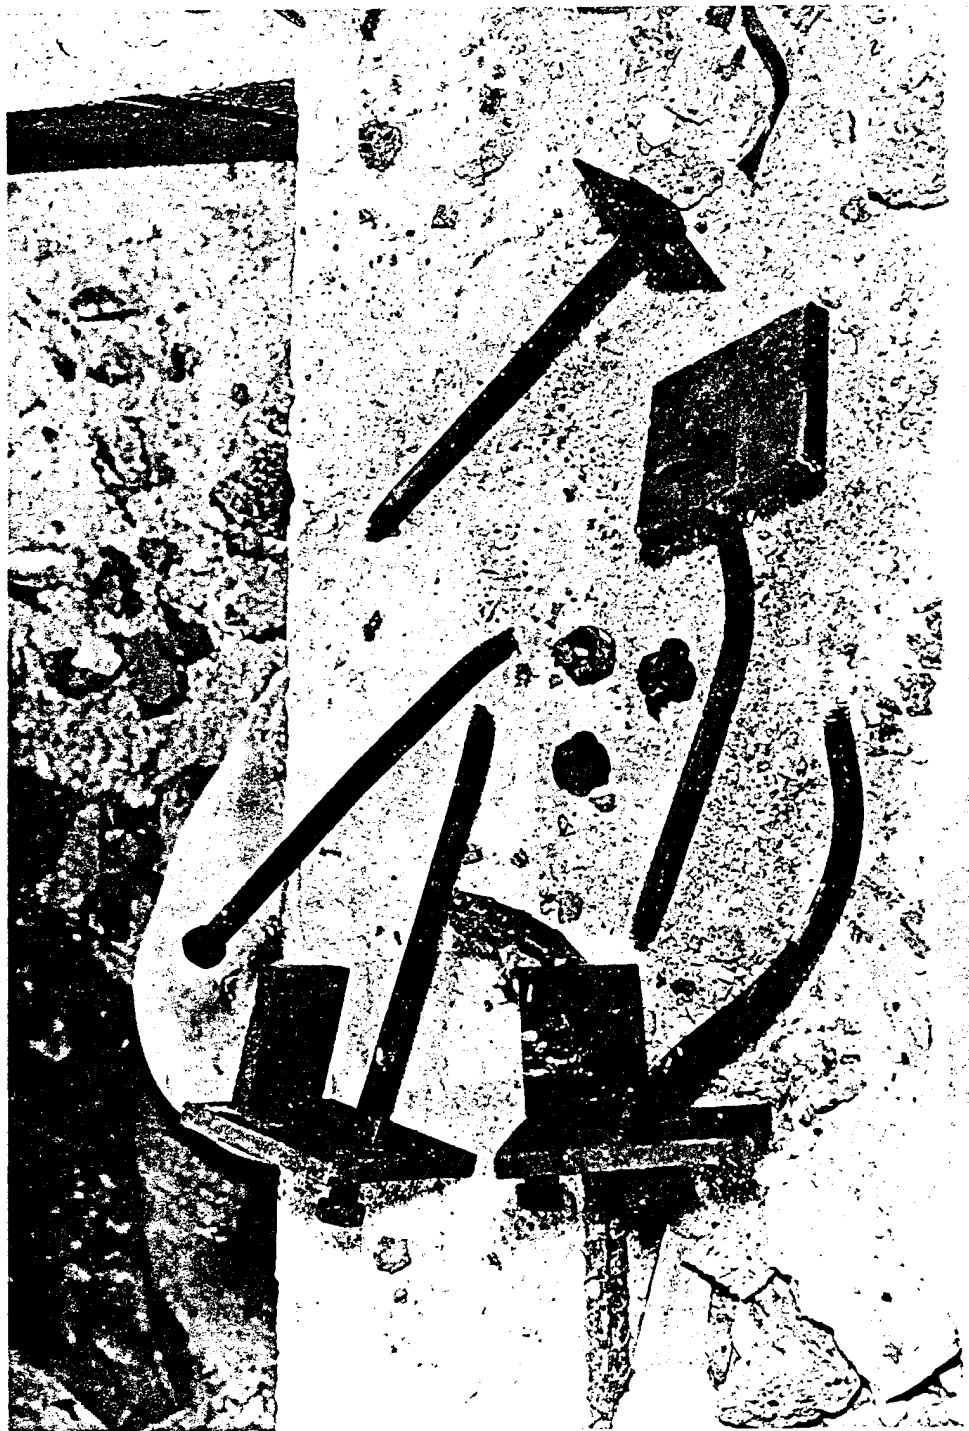
Fig. L.79 Tension Failure of Bolt Attaching Panel to Bent, Structure 3.2.2a

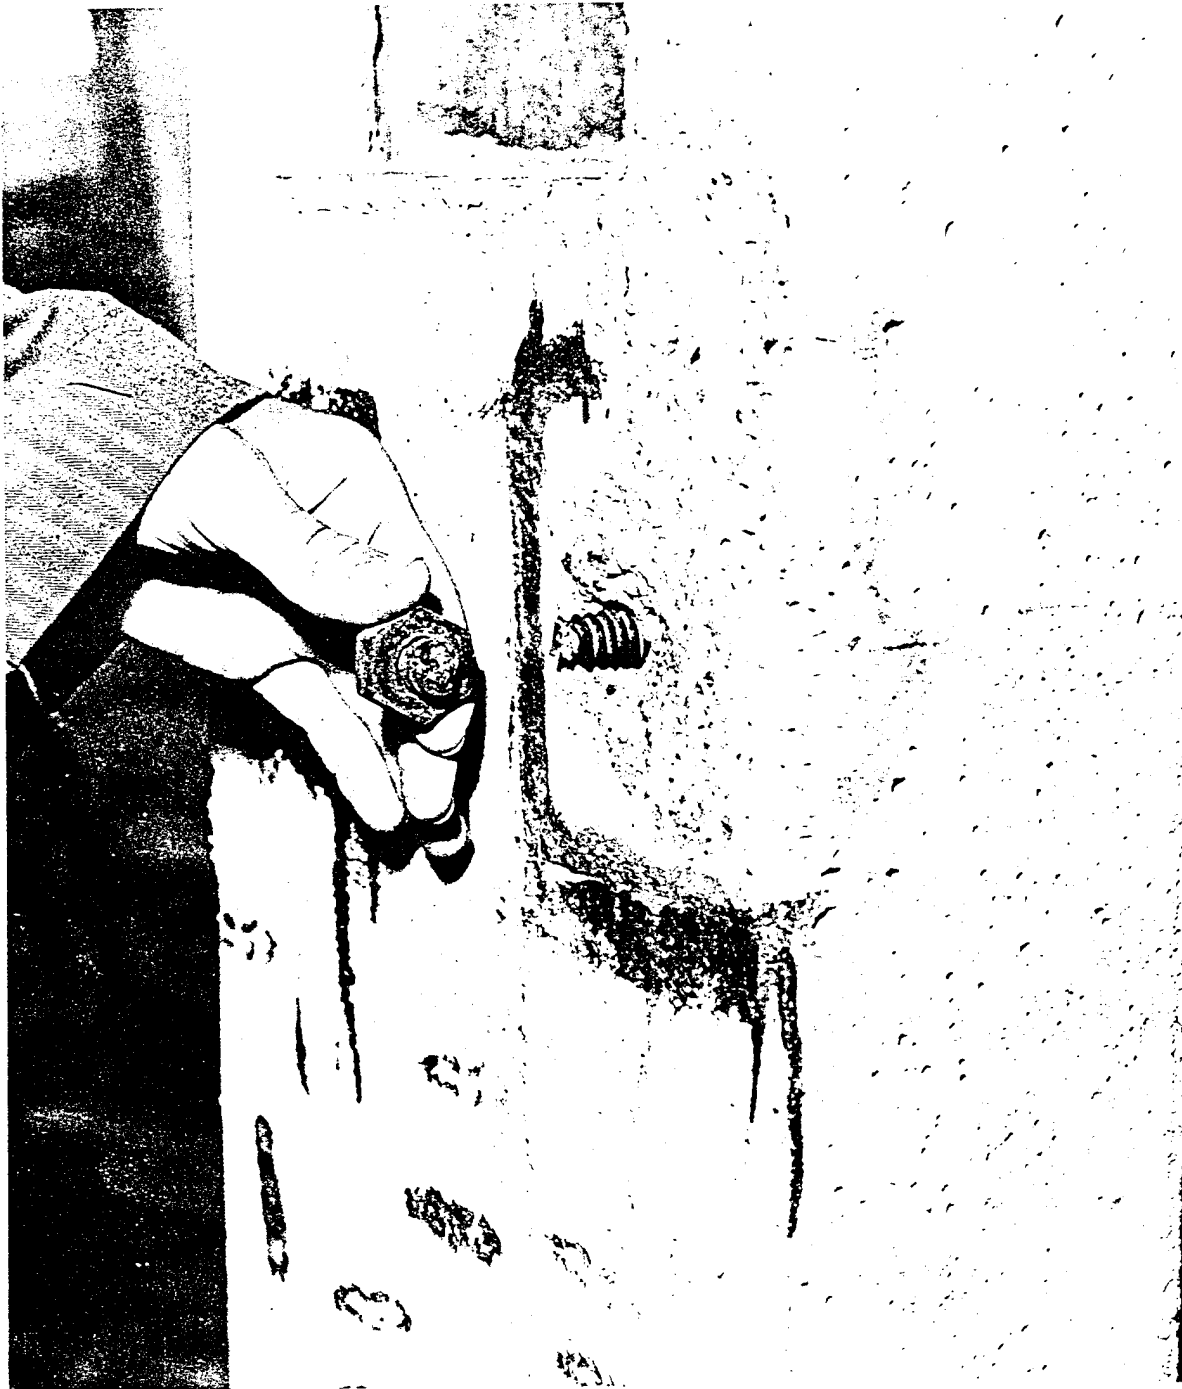
Fig. L.80 Typical Bent Bolt Failures, Structure 3.2.2a. Most failures occurred near nut.

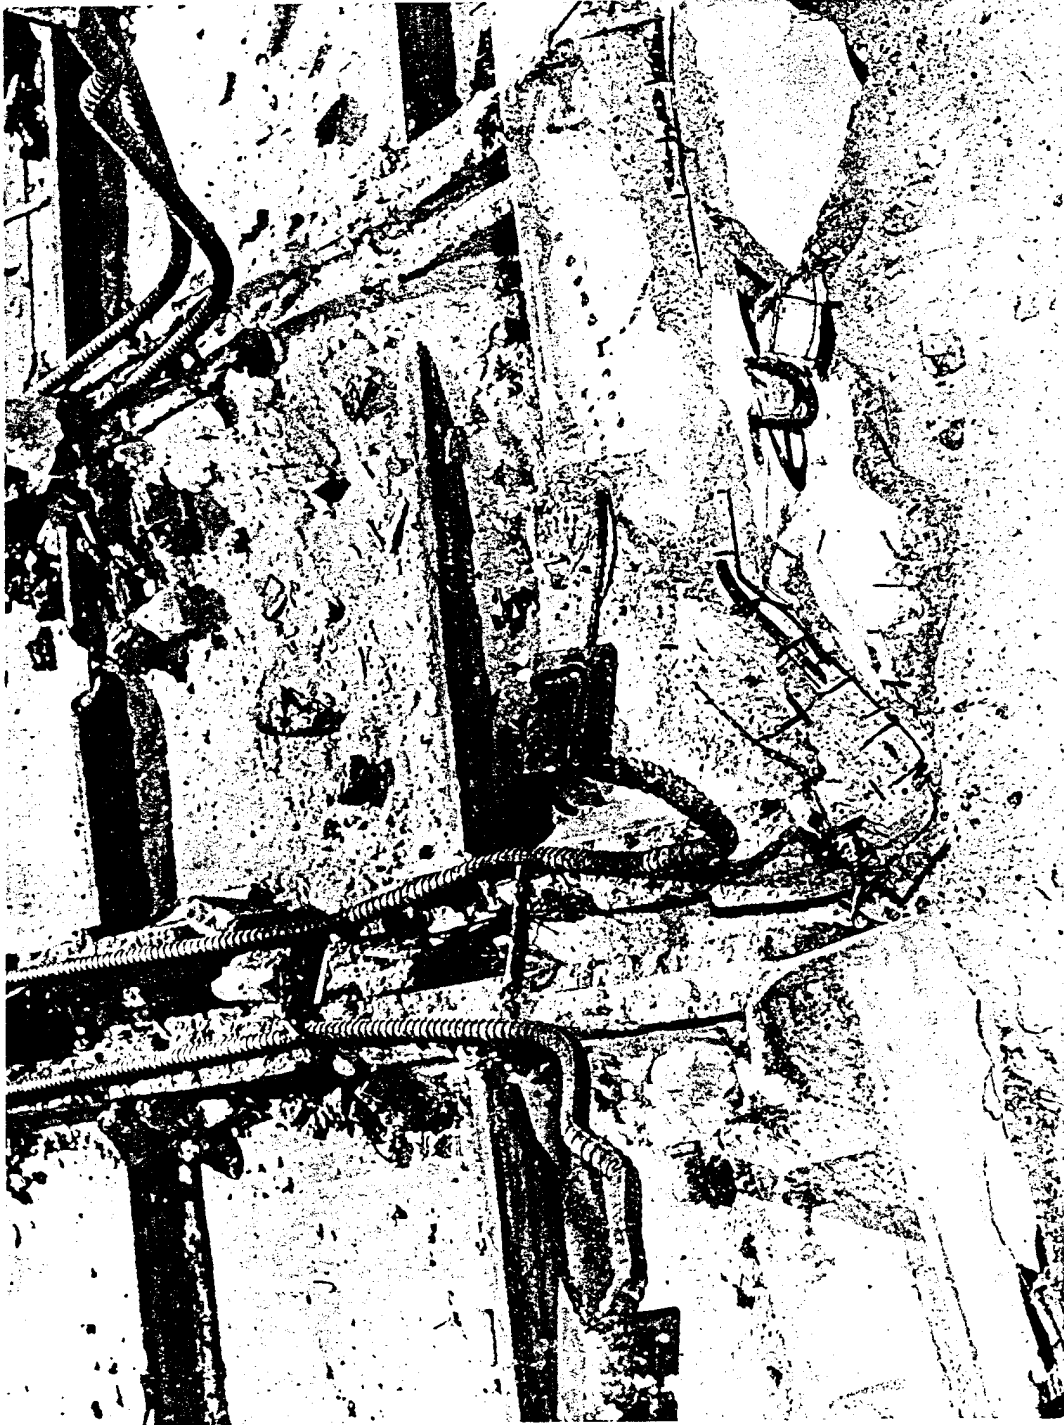
Fig. L.83 Welding Failure Between Top of Side Panel and Roof Panel, Structure 3.2.2a

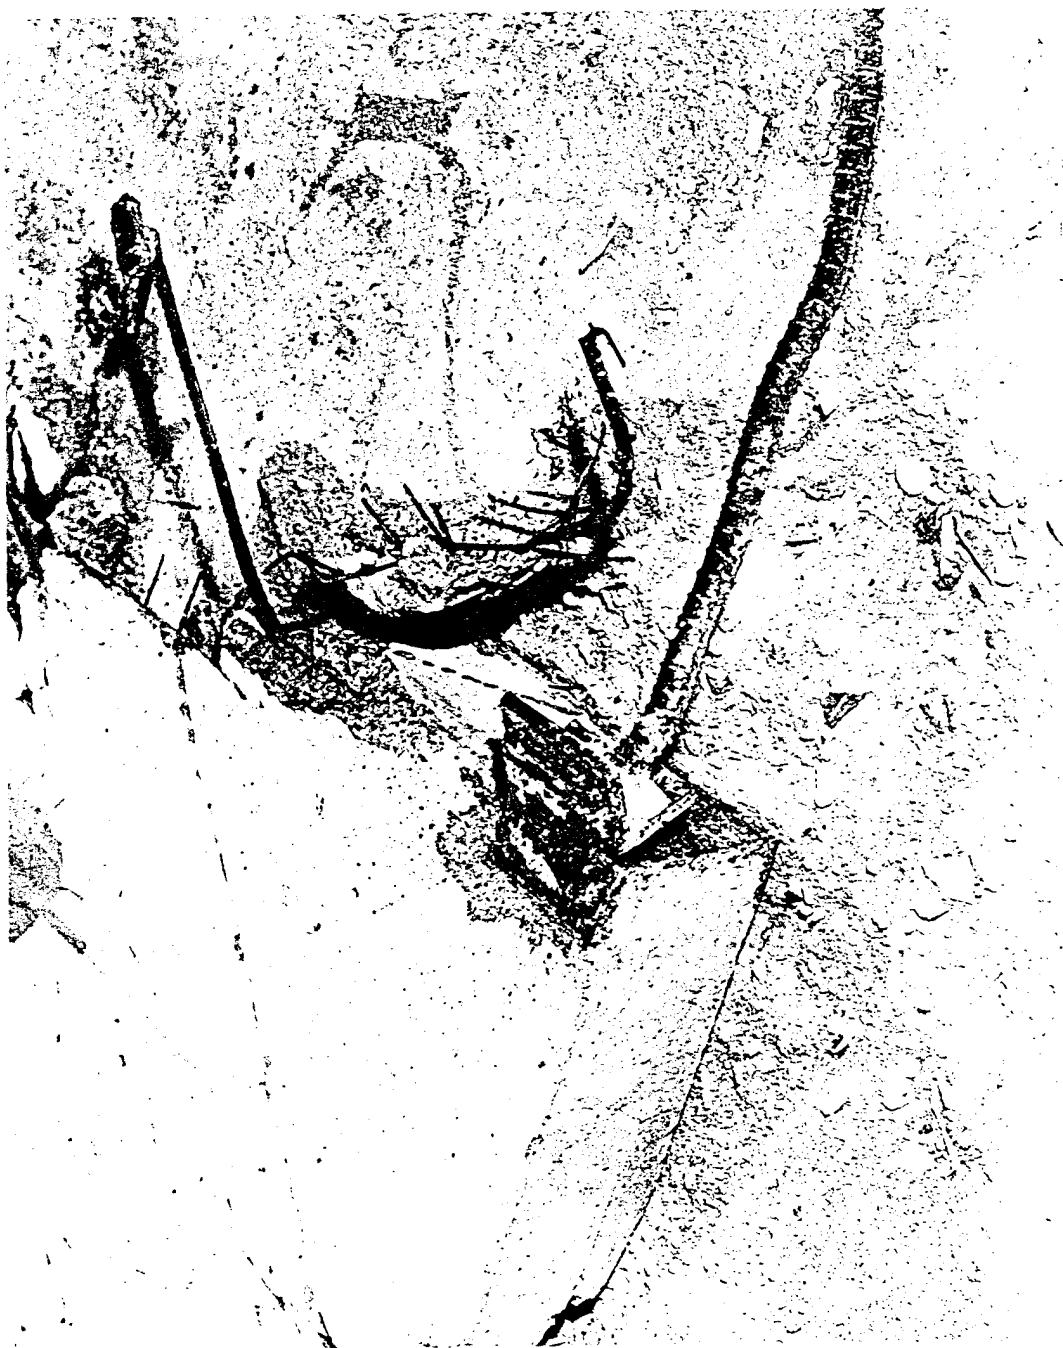
Fig. L.84 Connection on Roof Panel Where Angle and Steel from Side Panel Pulled Out and Remained Attached to
Roof Panel Through Splice Plate, Structure 3.2.2a
